Failed Inspections for 2024

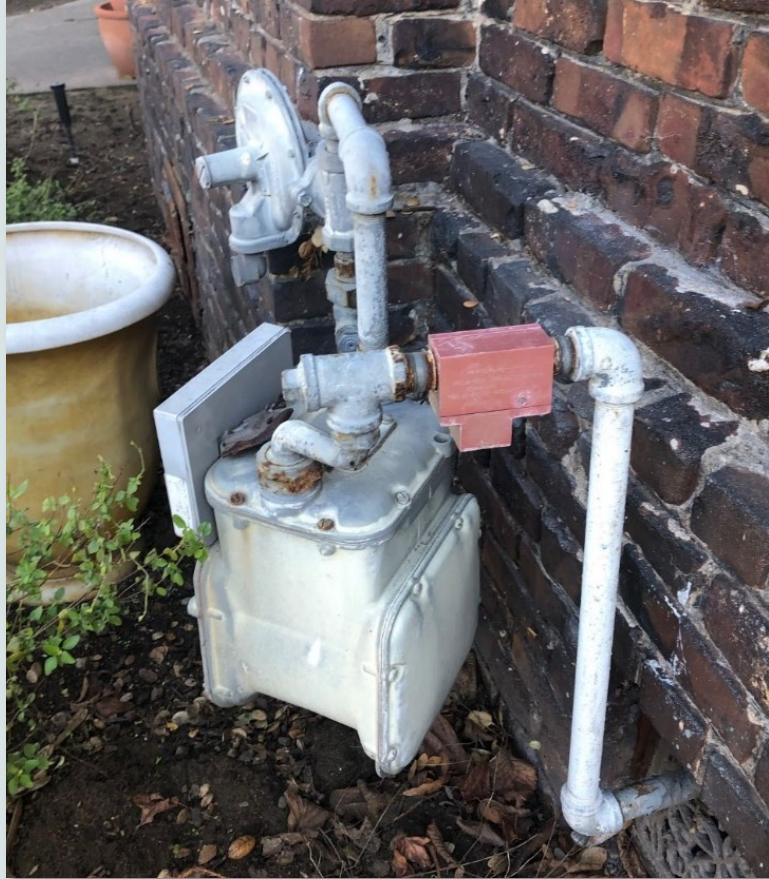
There is even an arrow to help the installer!

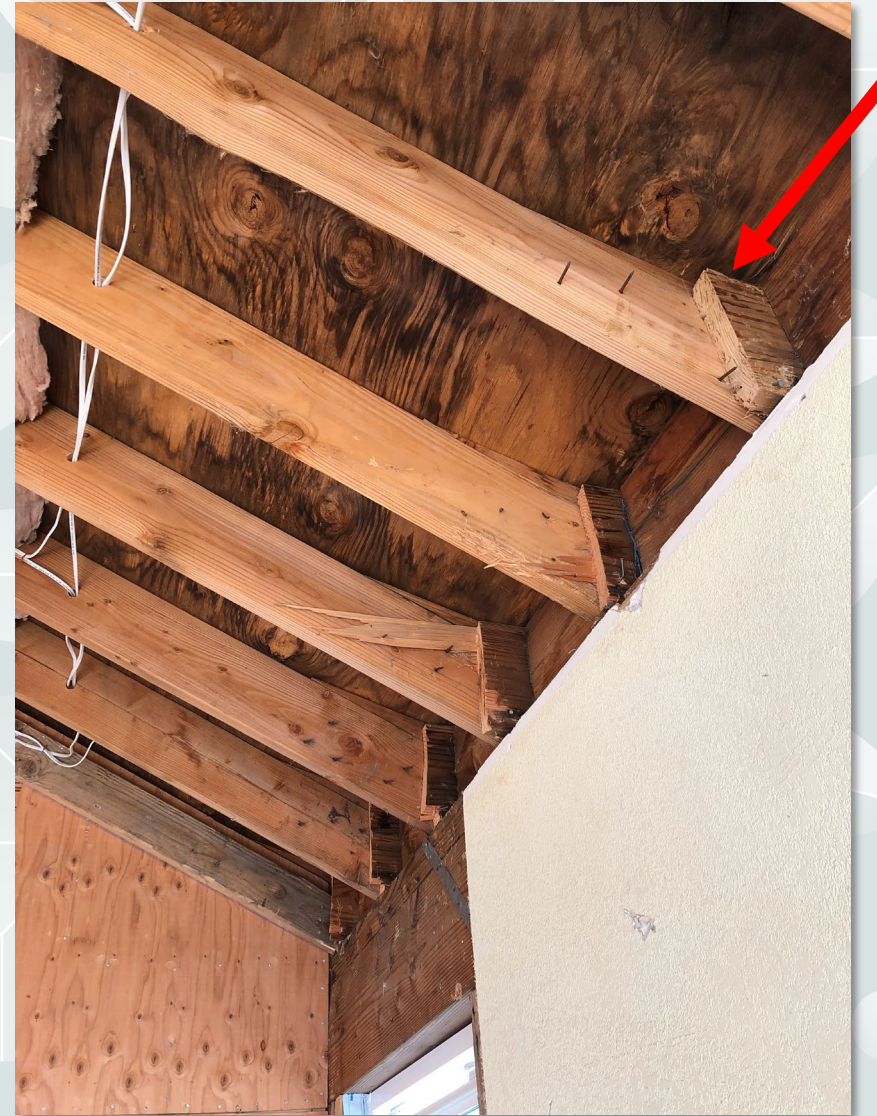
Not Following the Plans

Studs removed in load-bearing exterior walls.

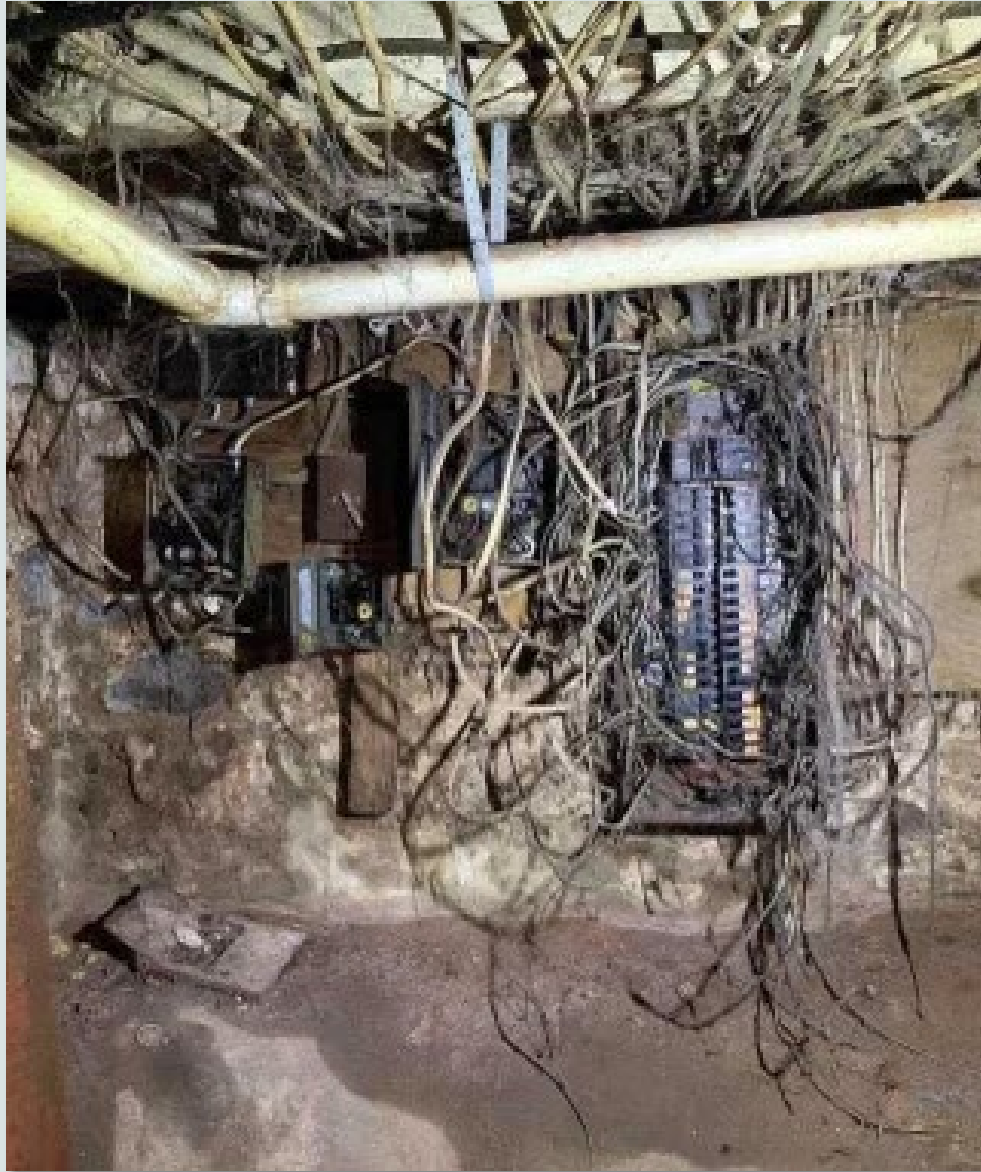
CEC 250.25.A.5: Neutral conductors on the ground bus bar & grounds on the neutral bus bar. The installer got it backward.

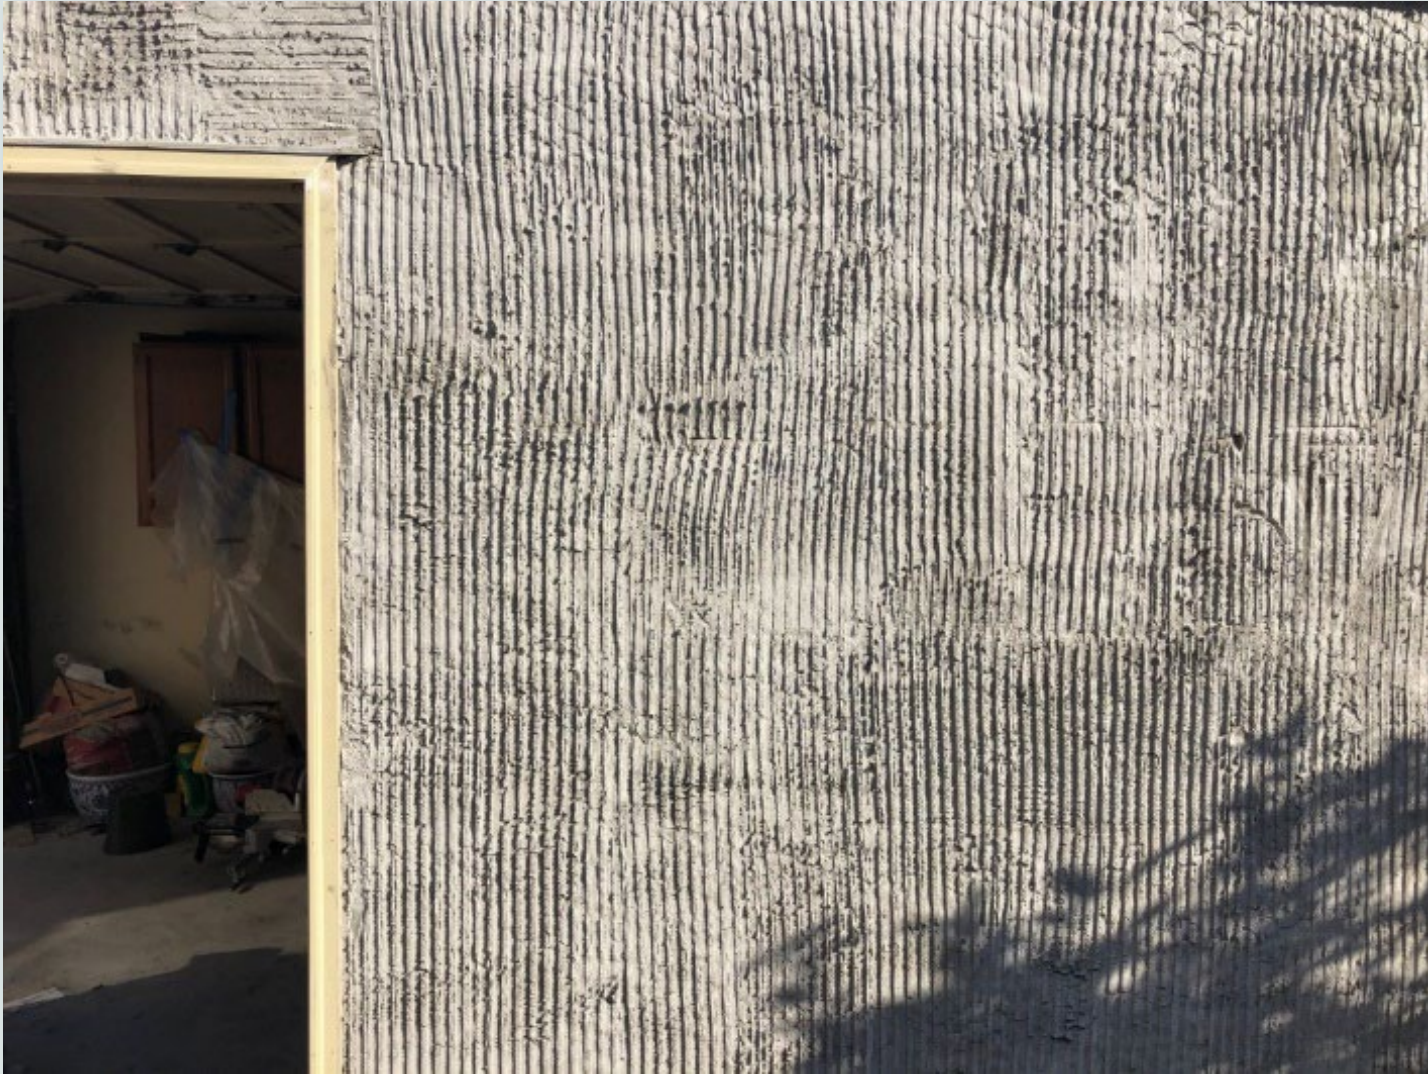
CRC R703.7: Missing scratch coat.

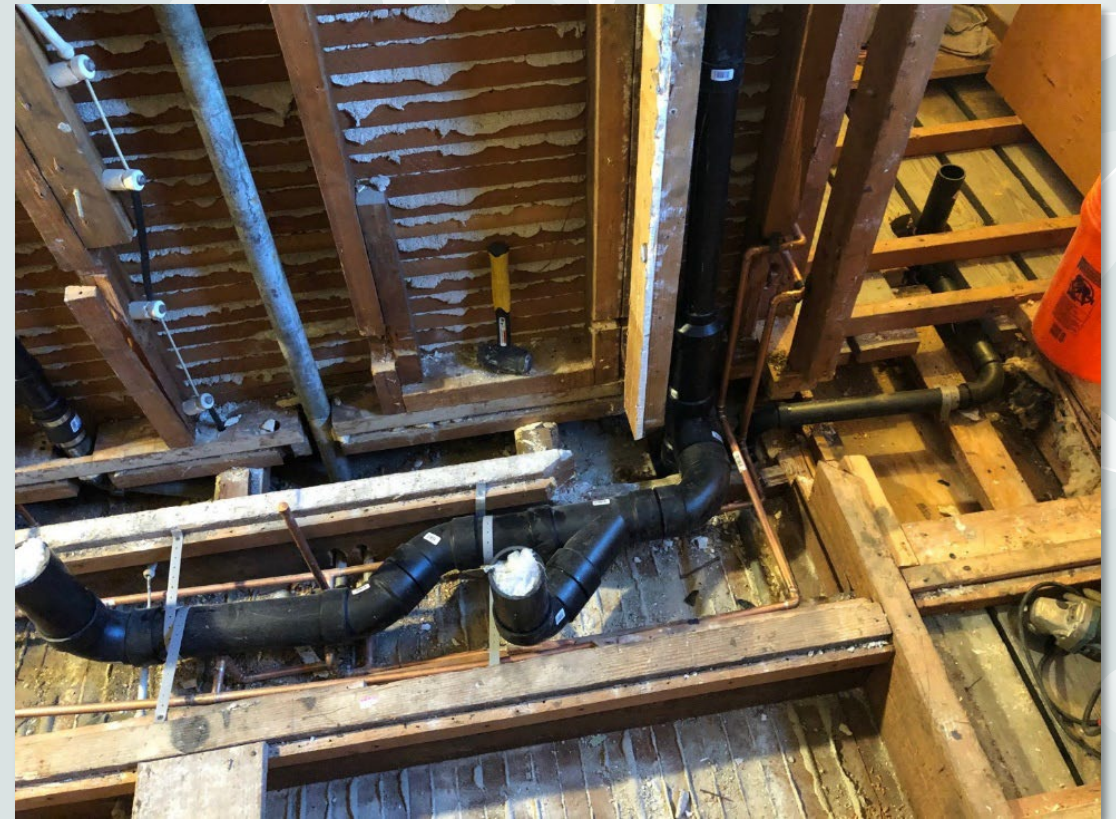
CPC 905.0: Backwards vent fitting.

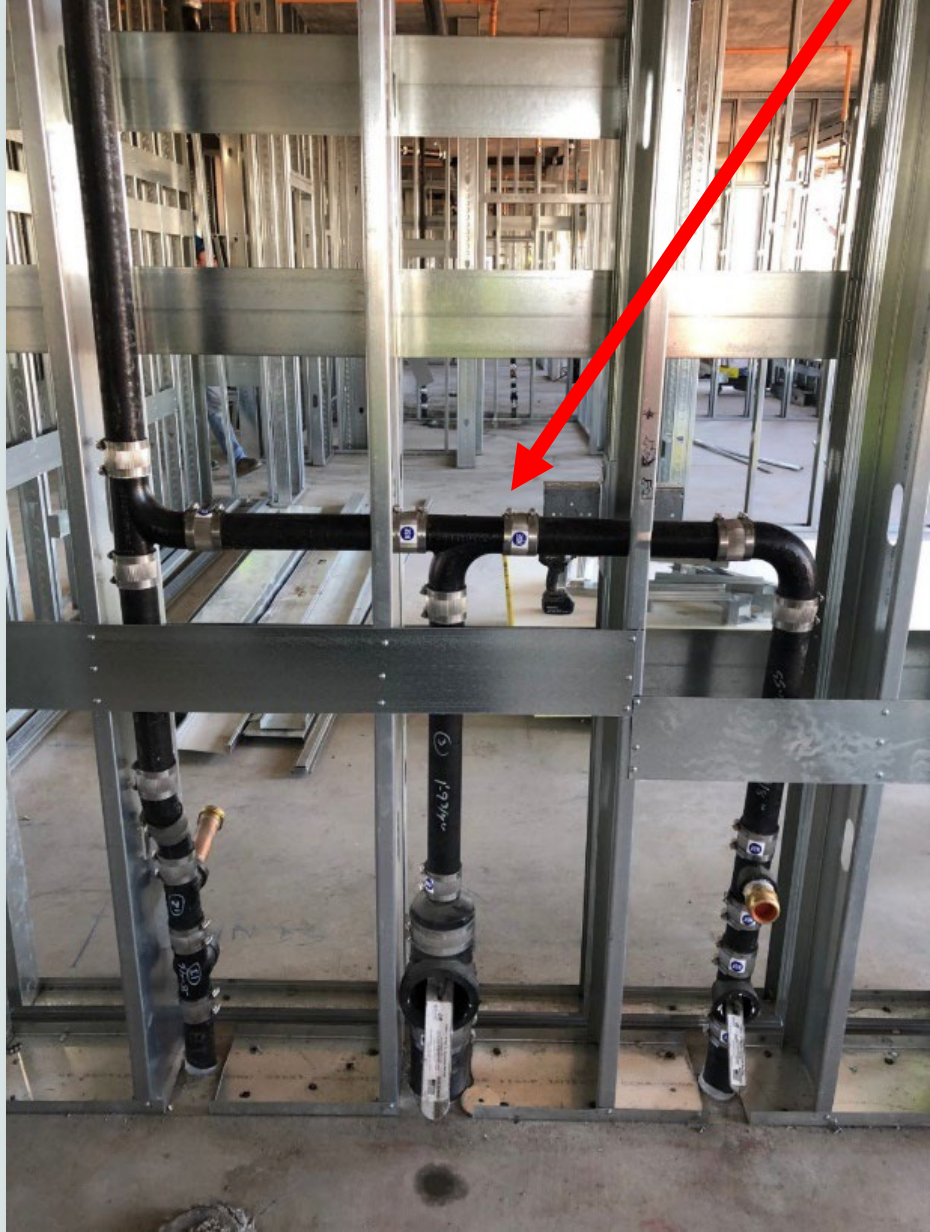
CPC 605.15 & 310.6: Dissimilar metals.

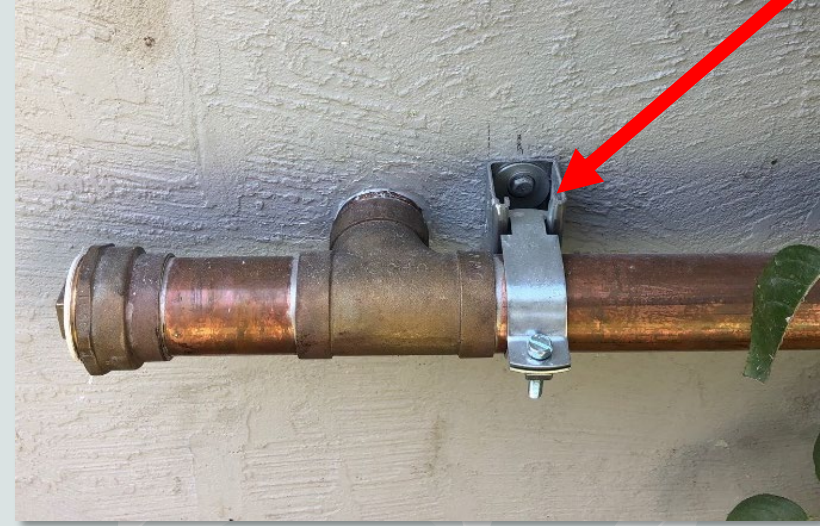
After time it will look like this and start leaking.

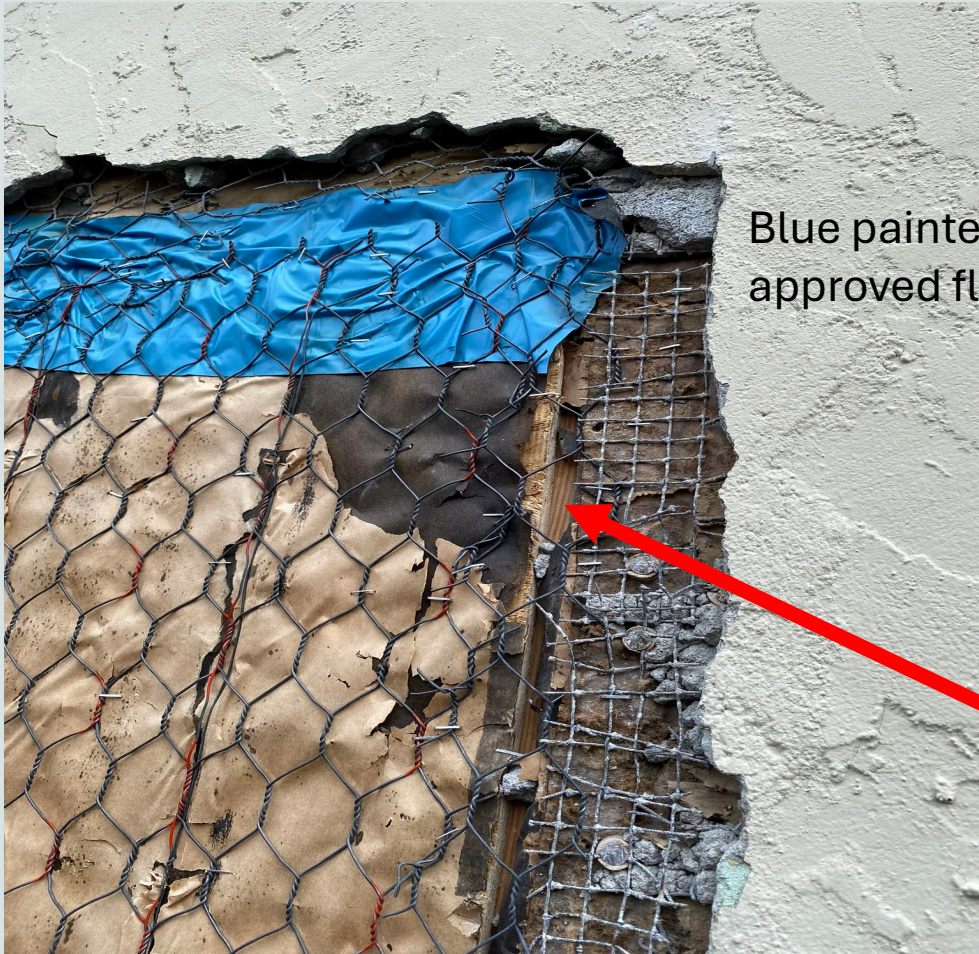
Blue painter's tape is not an approved flashing material.

CRC R703.7: Exposed plywood and framing seen during pre-stucco inspection

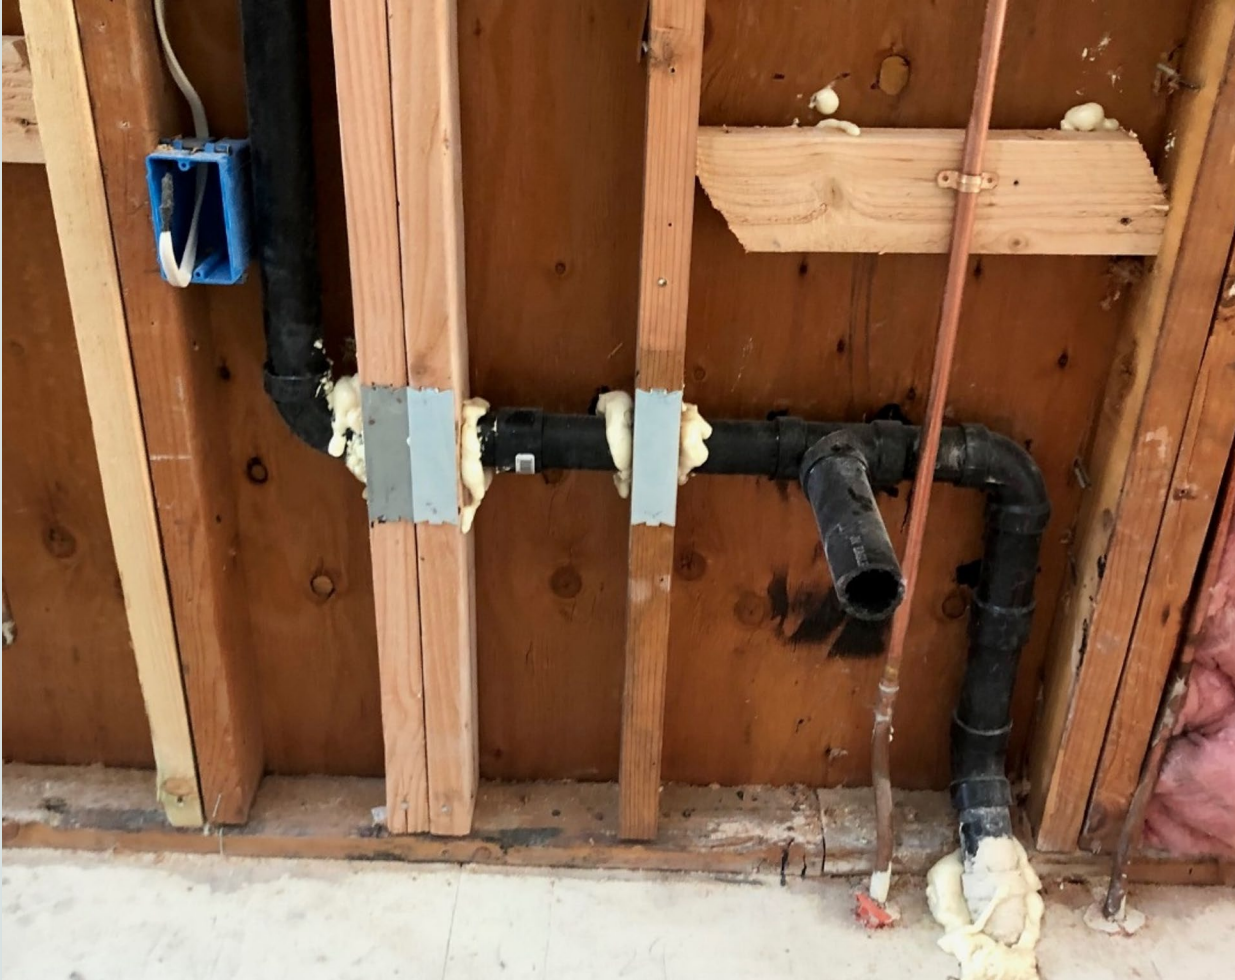
CPC 804.1: The laundry standpipe is too tall.
The trap arm is too short—missing nail plates.

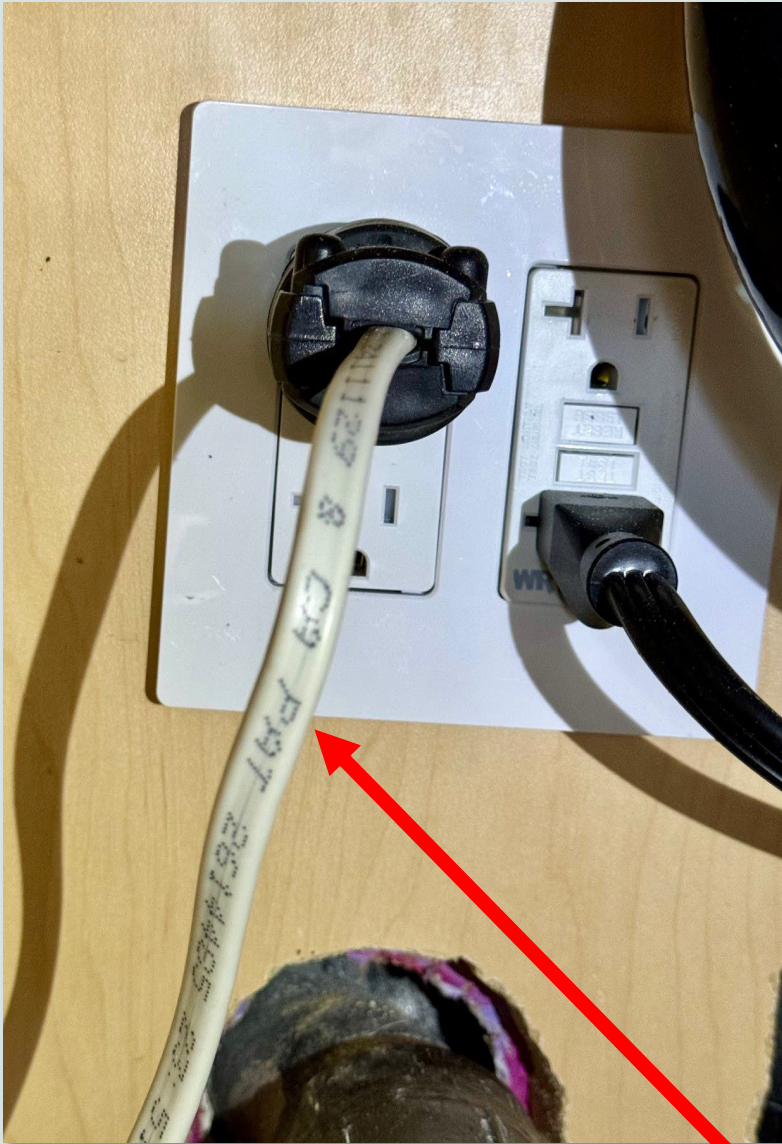
CEC 334.10: Romex is not approved for use as an appliance cord.

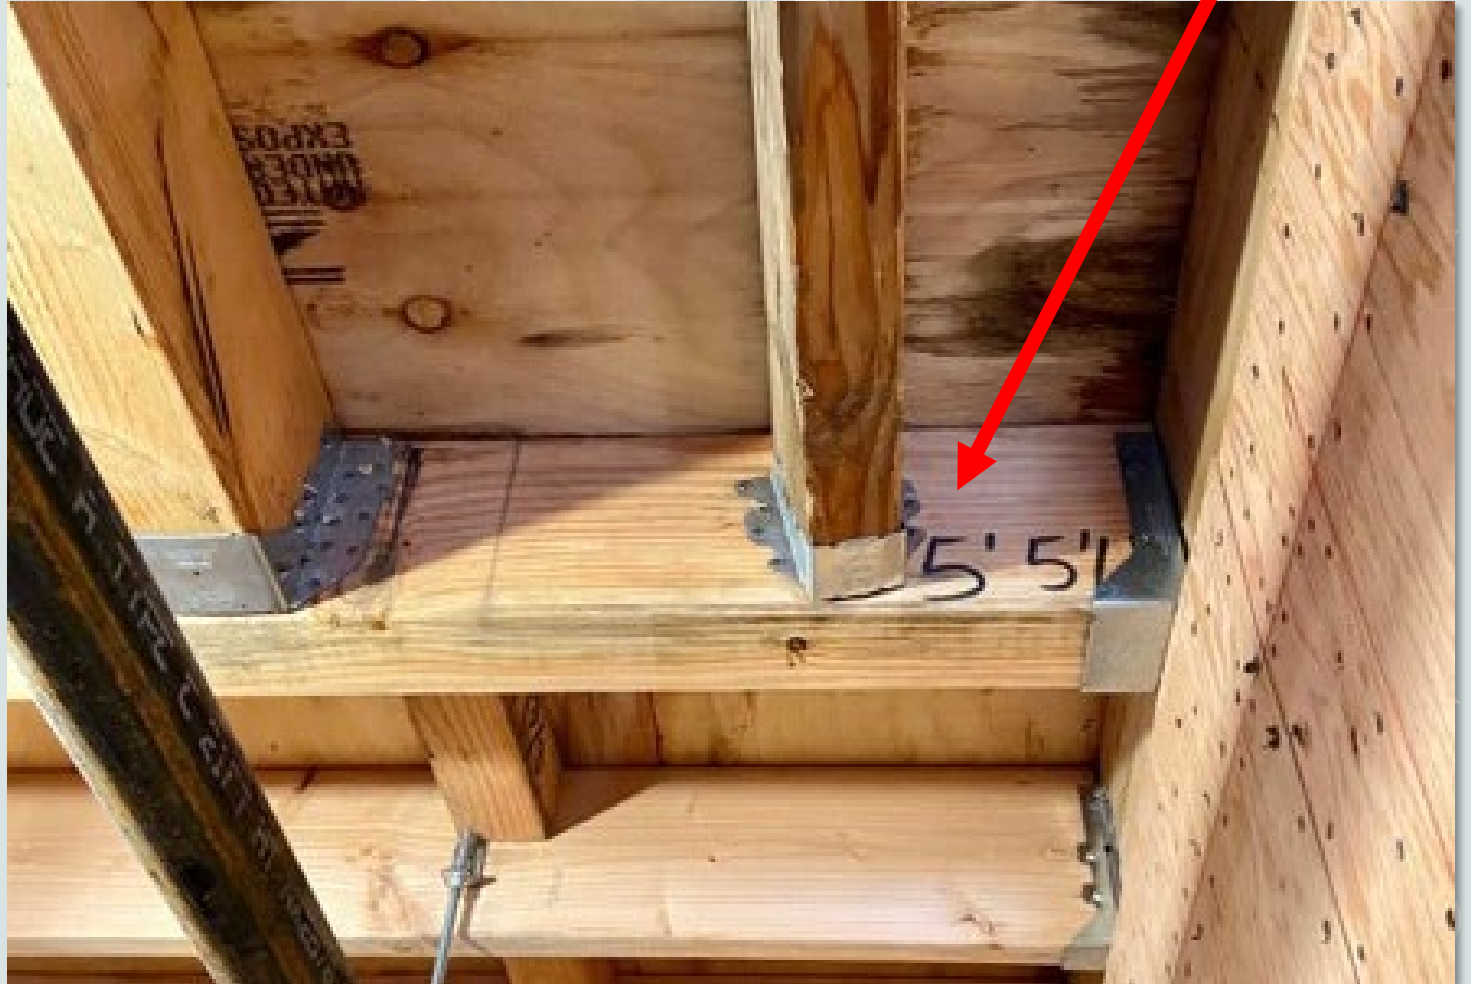
5-Story new construction.

That beam is a little twisted! Also, supposed to be a 6x8.

Missing nails in the hangers.

Shear walls are not nailed per plan.

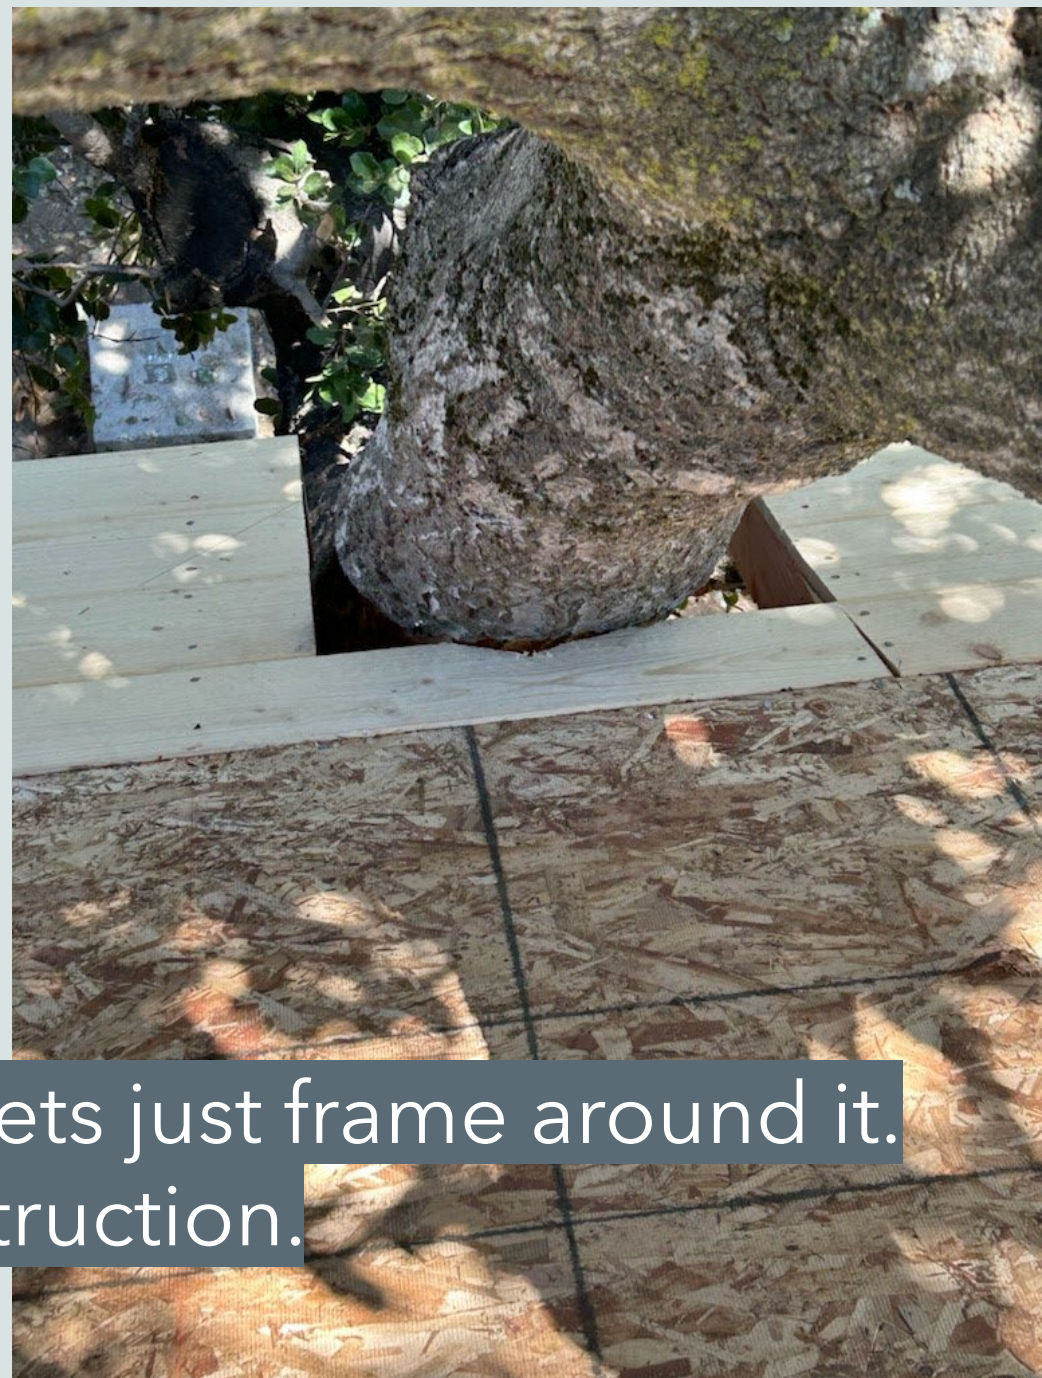
The tree is in the way so lets just frame around it.
New construction.

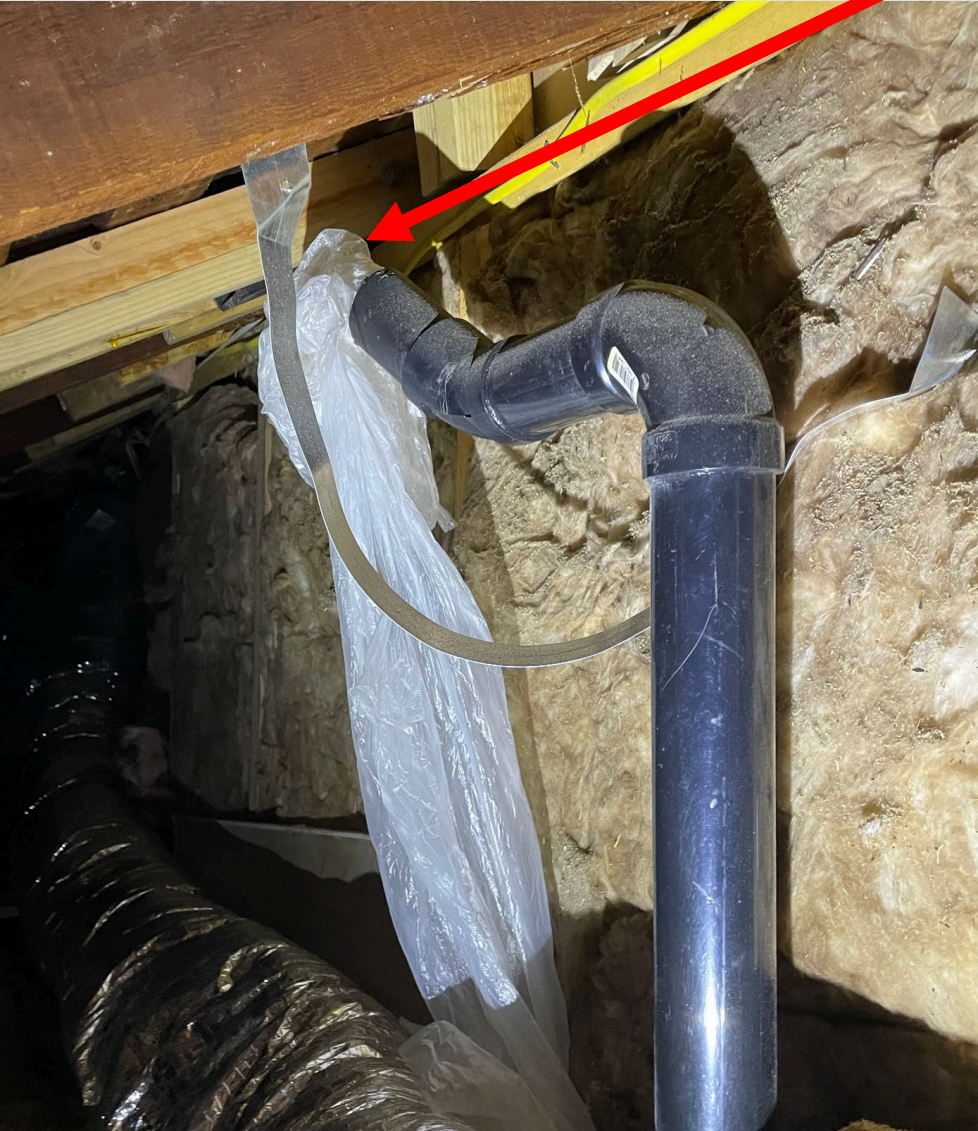
Stuffing a plastic tarp in the pipe is not an approved method for capping a waste pipe.

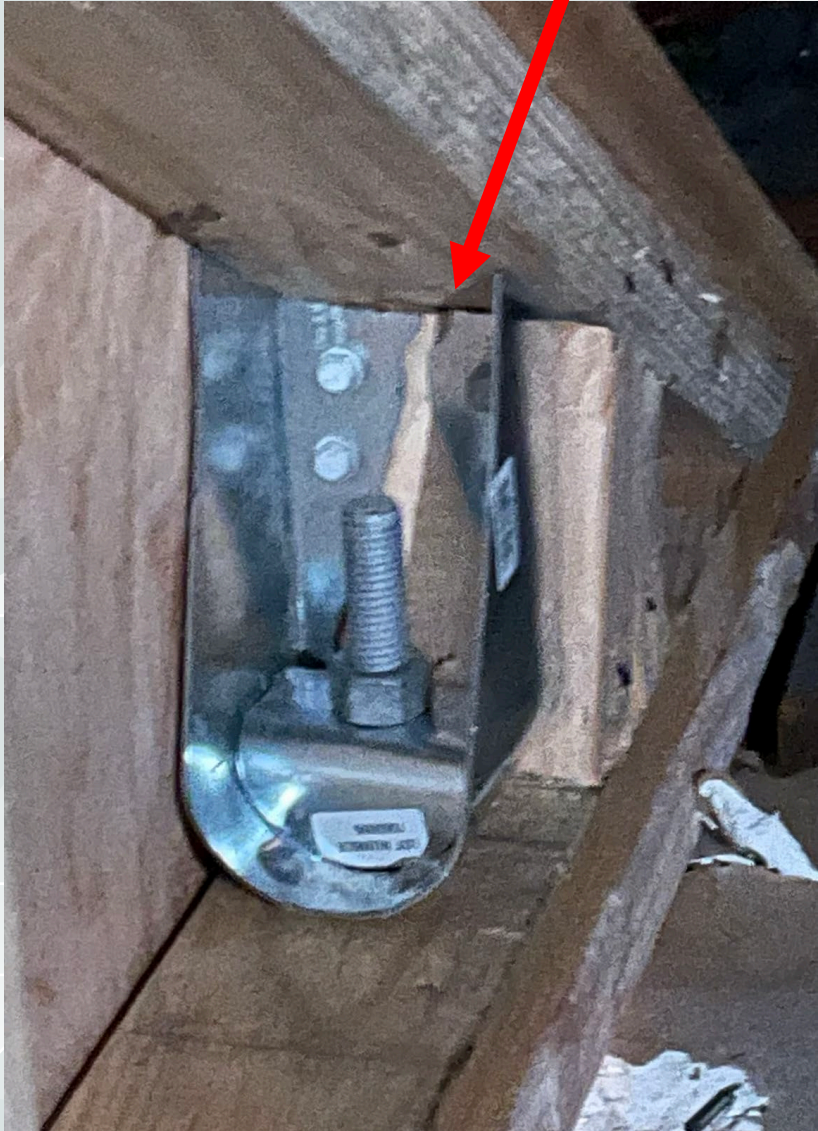
If the hold-down does not fit, then just cut it in half.

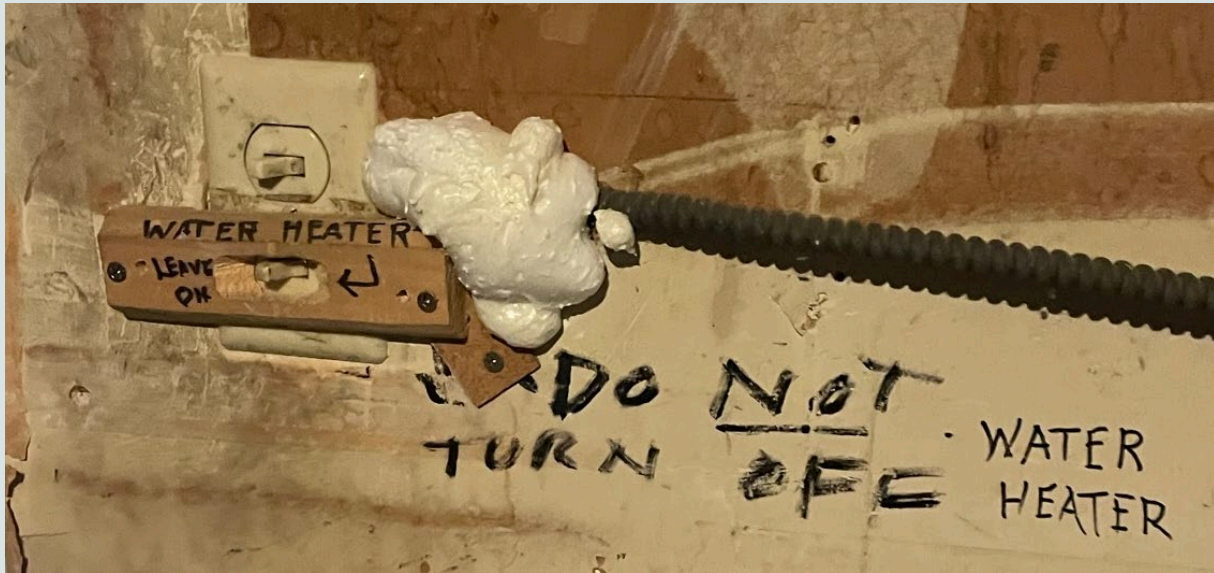
This is not an approved method for wiring water heater disconnect switch.

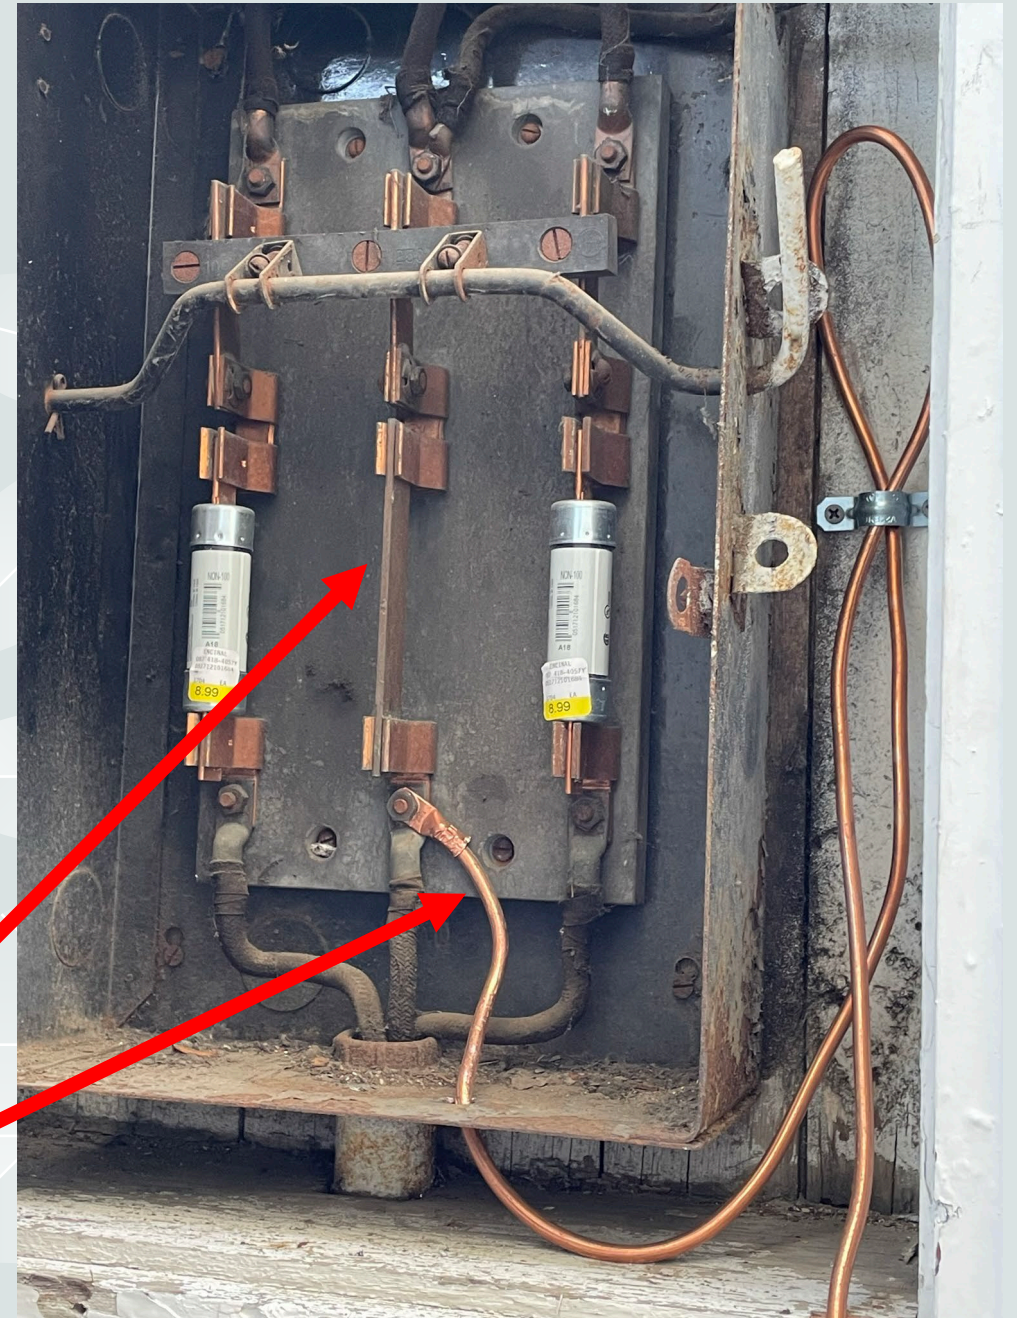
That is not a fuse

Bare Copper?

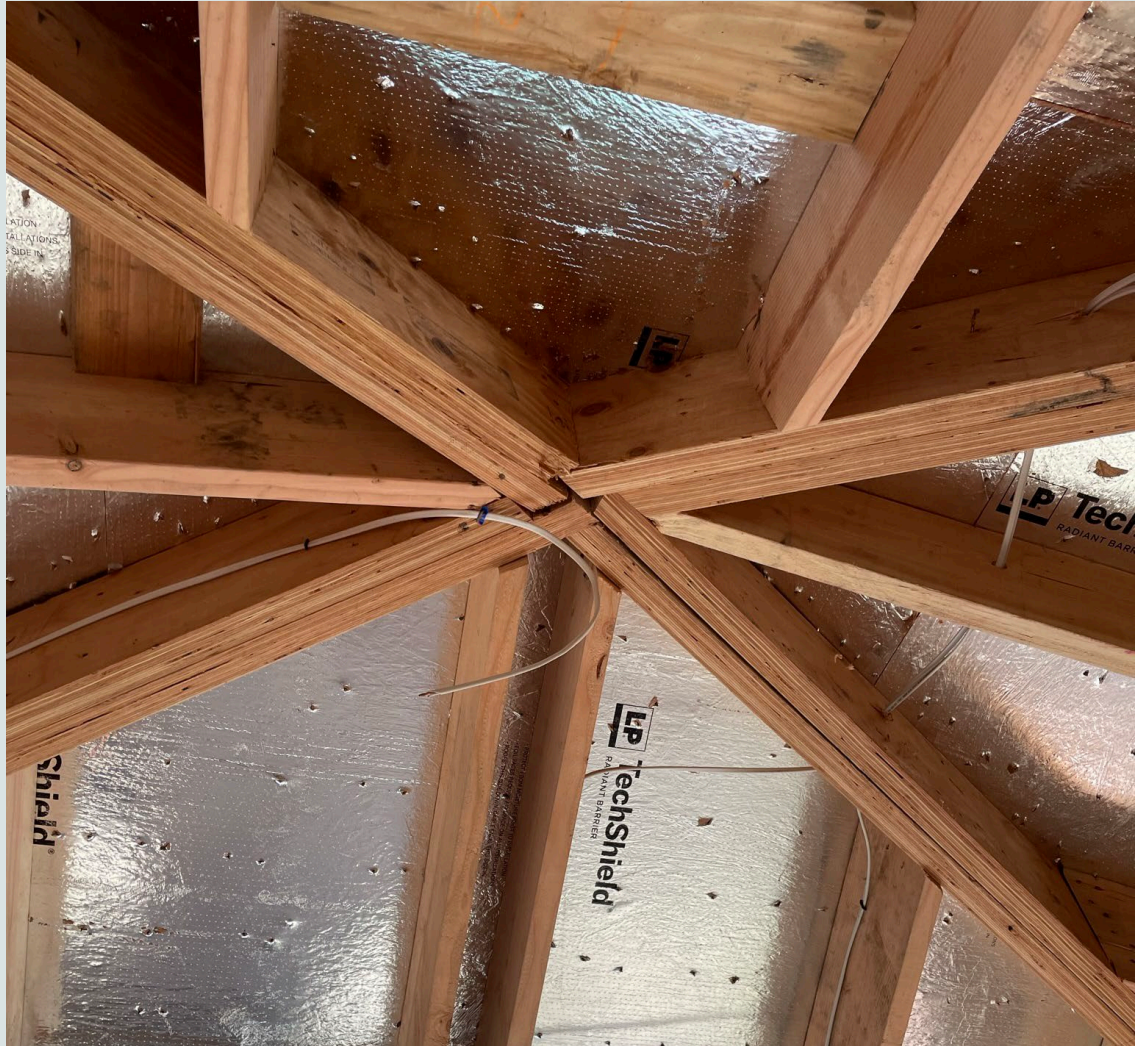
Did the plumber frame this?

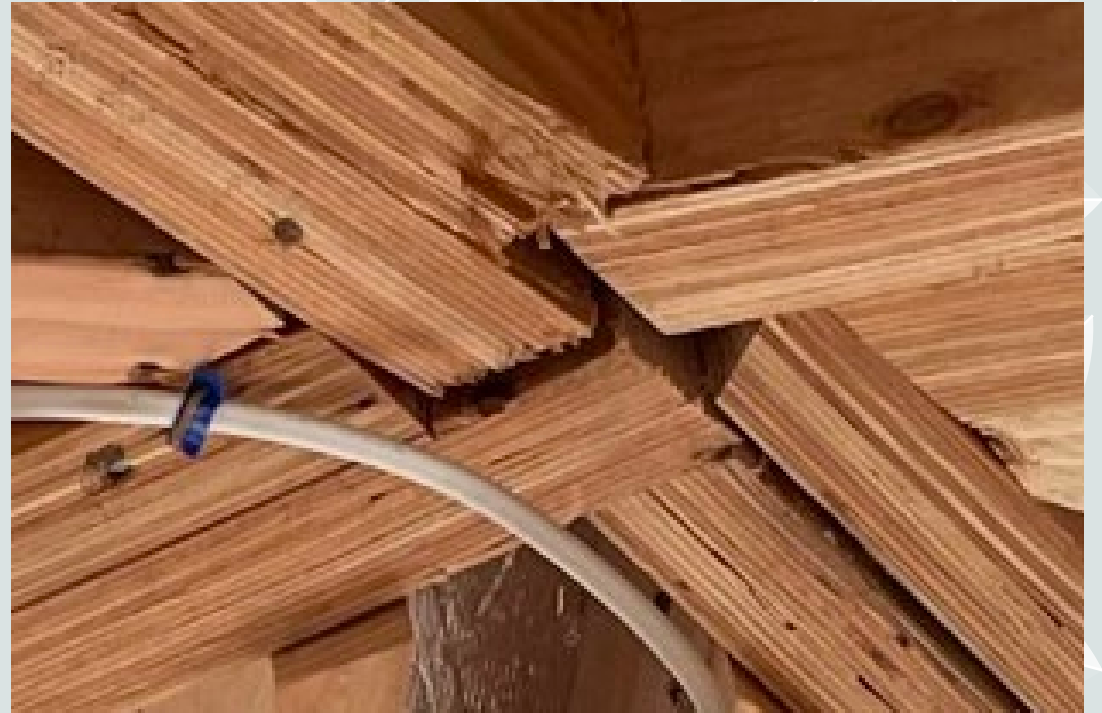
You cannot notch the foundation to install your plumbing pipes.
