Failed Inspections for 2024

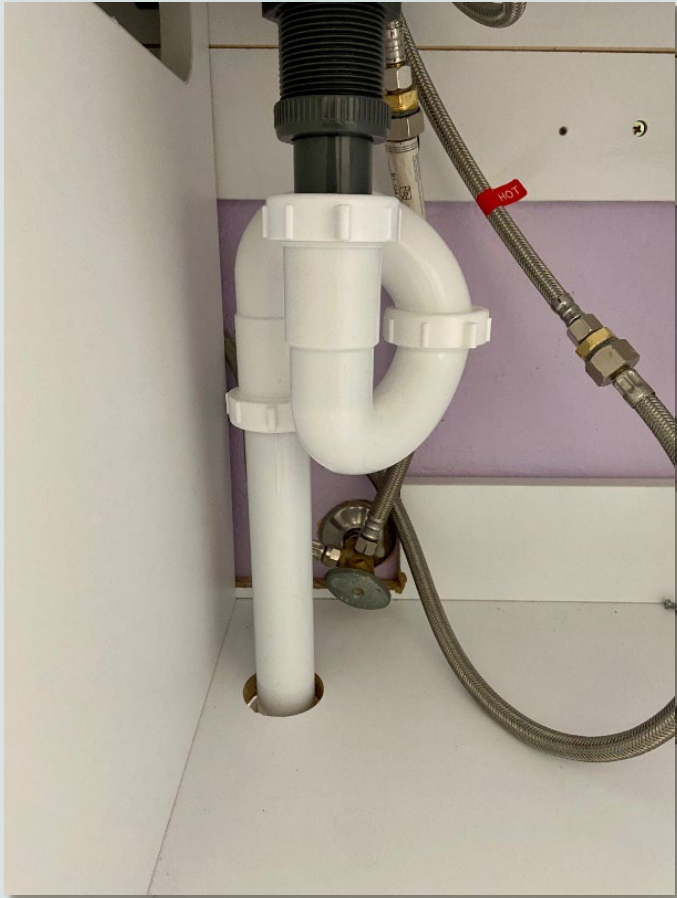
CPC 905.3: Each vent shall rise vertically to a point not less than 6” above the flood-level rim of the fixture served before offsetting horizontally.

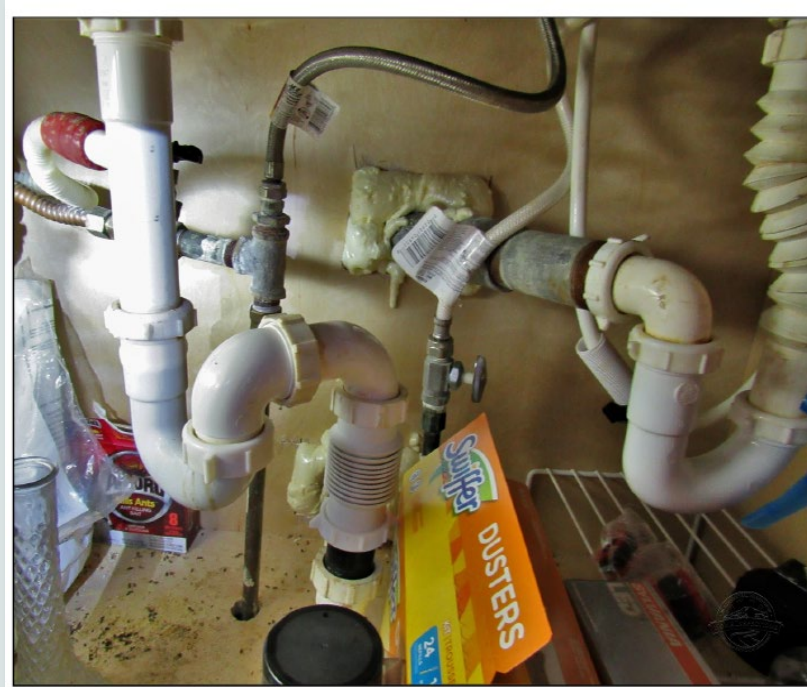
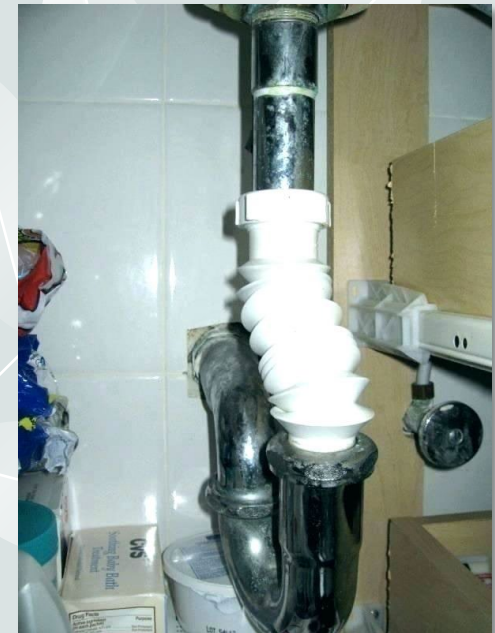
CPC 901.2: Each plumbing fixture trap requires a vent – Where is the vent?

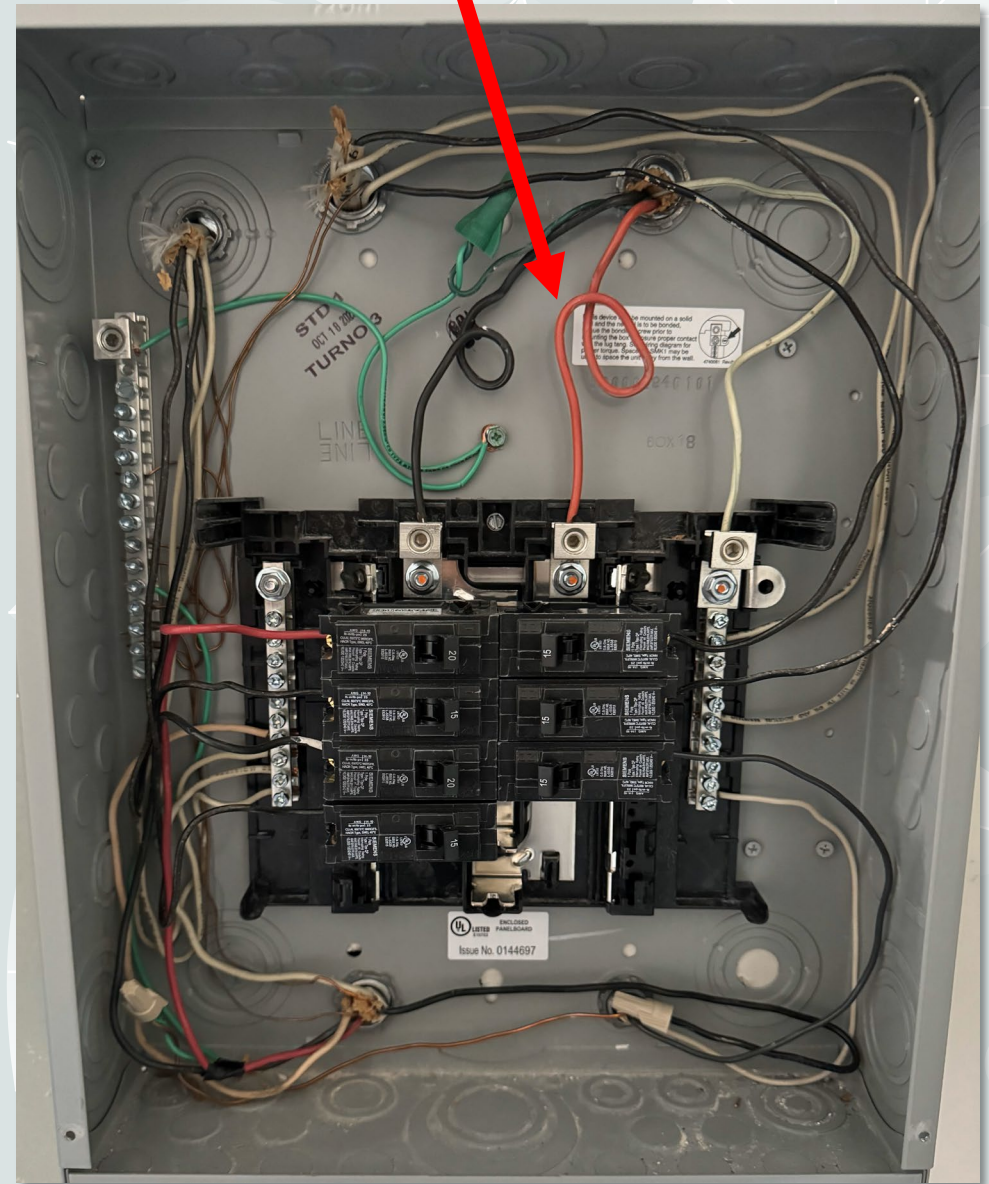
CEC 310.16 7 – 20 amp circuits in this subpanel fed by 12-gauge wire.
